Problems with modern diesel fuel injectors on low emissions engines

Summary

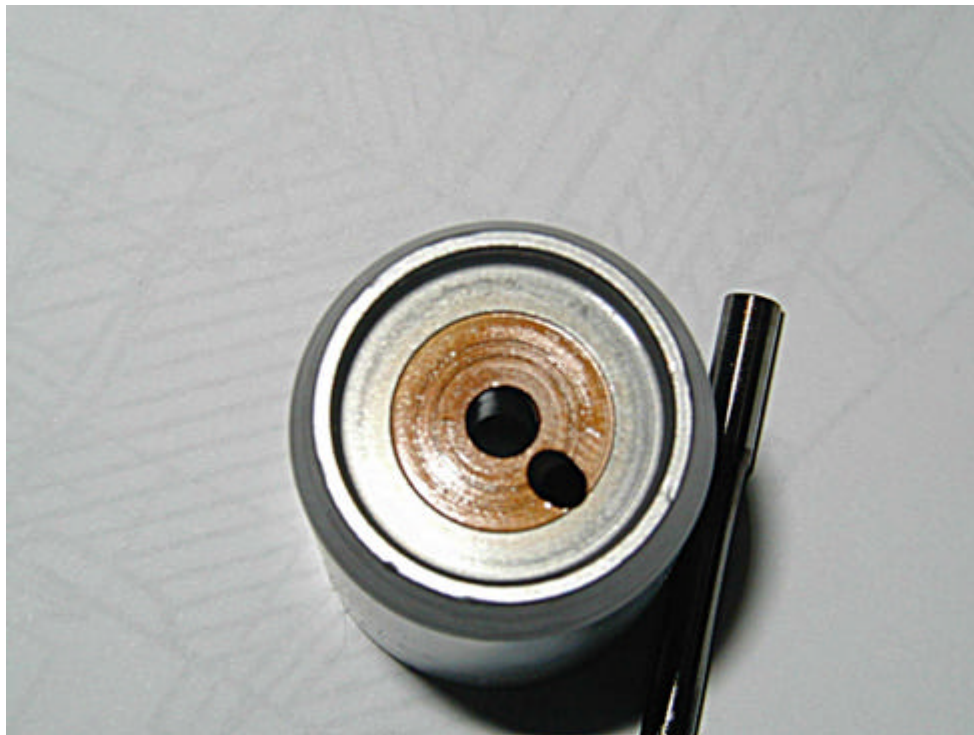
The modern diesel engine uses a fuel filter with a much finer mesh inside than was traditionally used and bacterial infection of the fuel may manifest itself in the form of short filter life. The problem is caused by the residue left behind in the fuel when the bacteria die. This can have the appearance of a brown coloured stain and can be removed from metallic surfaces it has come into contact with by gently rubbing it with a finger tip. This residue will stick to the filter and clog it fairly quickly but some of the residue will pass through the filter and end up on the surfaces of the fuel system. The photograph below shows an example of this coating on the back end of the fuel injector nozzle. The brown tarnish is only present where the fuel has come into contact with the metal.

The first course of action should be to identify the source of the bacterial infection. Air BP* sell an easy to use microbial test kit that allows the end user to identify the presence of bacterial infection in fuel. Once a source has been identified the user should contact their fuel supplier.

If there is found to be a bacterial infection in the fuel then it will be necessary to either stop using that tank or dose the fuel in the tank with a specific disinfectant. The fuel in the tank will then have to be filtered using a special filtration system to remove the bacterial residues. It may be more appropriate to install a new tank and review the process used to maintain the tank with respect to water drains and tank breathers.

- 1) Shut the engine down in a controlled fashion, idle down as you would for a turbocharger. This will help prevent the engine from heat soaking the injector.
- 2) If it is necessary to shut down the engine in an emergency try get it restarted as soon as possible and allow it to cool down as above.
- 3) Use fuel from a known "clean" supply and avoid using fuel cans wherever possible.
- 4) Check your fuel tank regularly for bacterial infection, just before ordering the next batch of fuel to limit the amount of cleaning required.
- 5) Look out for signs of bacterial residue during filter changes and use short filter life as a warning of possible problems.

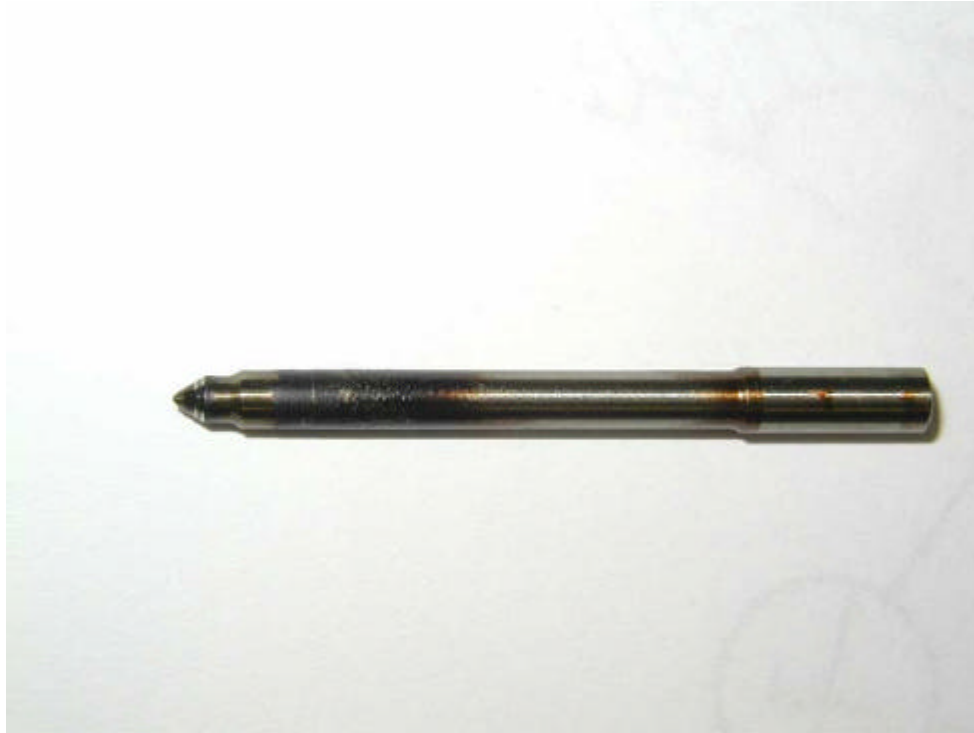
More serious is what happens when the bacterial residue is heated. The photograph below shows the needle from the same injector nozzle assembly:

In this case the residue has been carburised (turned to soot). This is not because the needle has been leaking; right up until the failure of the injector the engine was running evenly and the emissions analyser measuring the exhaust gas from the engine showed no signs of a fault of this nature. The engine had been shut down from full power (850 HP) by an alarm trip and the injector was found to be faulty on re-start, some thirty minutes after the original shutdown.

The carburised look comes about because the bacterial residue contains a lot of sugars which are being caramelised by the heat. This does not require a particularly high temperature to take place either. On this injector it was necessary to use a brass drift to punch the spill control valve spool from its body. When the spool was removed it was found to be covered in a dry residue showing partial signs of caramelising.

The spill control valve is surrounded by the windings of the electromagnet used to operate it. The windings are normally cooled by the fuel flowing through the spill control valve. In the event of a fast shutdown of the engine after heavy work or due to an emergency stop the heat from the engine “soaks” up through the cylinder head and up through the injector causing the temperature of the spill control valve to rise. The temperatures seen on an engine shut down in this way can be very high because the water pump is not moving the water round the engine and “after boiling” can take place. Because of this the temperature around the spill control valve may rise high enough to cause the bacterial residue to become caramelised. The sticky layer of caramel in the very tight clearances of the spill control valve will exert enough force to prevent the valve from operating and the injector fails.
